Minerals Inspection Report

Mine Name: Bromide Basin	Permit Number: S/017/0031	Mine Status: Active
Operator Name: Bromide Mining LLC.	Inspection Date: 08/04/2015	Permit Fees: Paid
Inspector(s): Wayne Western	Inspection Time: 11:15 - 12:15 pm	Bond Amount: \$57,600
Attendee(s): John Reay	Weather: warm and sunny	Bond Escalation: 07/22/2017
Inspection Purpose: Routine inspection		Prior Inspection: 07/09/2014

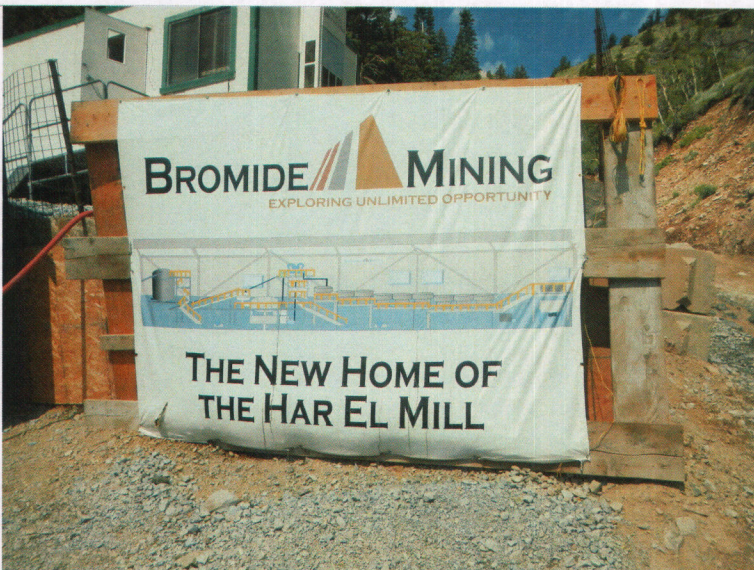
Proposed design of Har El Mill

The Operator must update the NOI and bonds to reflect the on the ground conditions; specifically the bond must be increased to cover the demolition of the new buildings.
